Geological Matters

Building stones: an introduction

Pinnacles of the Houses of Parliament

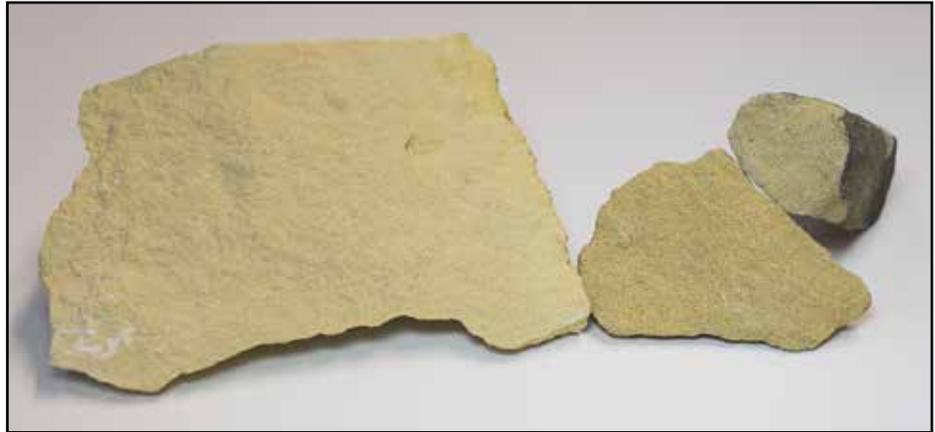
Left: Clipsham
Centre: New Anston
Right: Pinnacle Anston

In Ketton quarry the limestone is 20 metres thick, barely two metres of which is freestone. Freestone was mined in the past, but the quantity available may have been too restricted for extensive use in the Houses of Parliament. Clipsham stone is oolitic, just like Ketton stone. Both have such high porosity that water entering the pore space can readily drain out. This improves frost resistance.

Clipsham stone has been used as a replacement in parts of the Houses of Parliament, York Minster and a number of college buildings in Oxford. Both Clipsham and Ketton stone are suitable for copings, cornices and for monumental work.

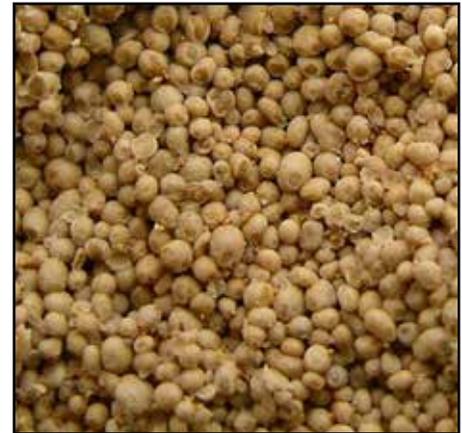
Ketton freestone - close up showing ooids, each about 0.5mm diameter

The pale brown Jurassic limestone found at Ketton and nearby quarries was formed about 170 million years ago when England was located about half way between the equator and its present position. The Gulf coast of Florida and the Florida Keys would be a reasonable modern analogue for the depositional environment of the Jurassic at Ketton. Ketton freestone, which is an oolitic limestone, has been widely used for building stone for hundreds of years. Many buildings in the centre of Stamford and several Cambridge colleges are built from it. The close up picture of this freestone shown here reveals that it consists of unimaginable numbers of ooids without much cement holding them together. If you look carefully you can see small scars on the surface of each ooid marking the points where this piece of stone was fractured. Despite this lack of cement the stone is strong enough for most building applications. Ketton's limestone, and other similar oolitic limestones, is called freestone because it has no preferred planes of weakness along which to fracture. This makes it easy to carve. In contrast consider roofing slate, which preferentially splits into parallel sheets,

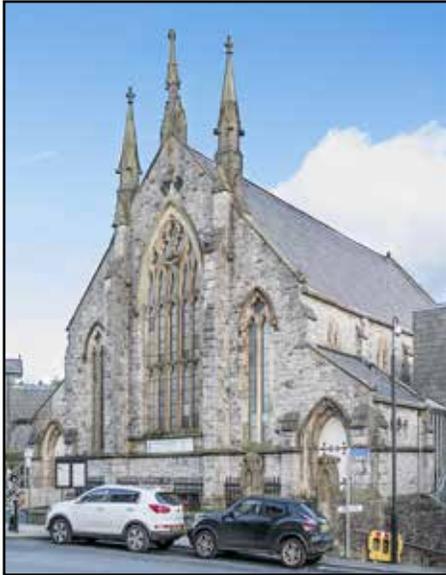
United Reformed Church
Moor Lane, Clitheroe

You can see the results of self-healing on the Clitheroe pinnacle. The skin largely hides the true texture of the limestone, which is not oolitic. You have to search very diligently to locate an example of the original texture and you will need a magnifying glass to see any of the small number of shell fragments.

The front of Clitheroe's United Reformed Church, located near the top of Moor Lane (see image shown here), has been built with limestone from Salthill. You can see spectacular examples of crinoid stems in the limestone blocks of the façade (see images overleaf). If there is any carved crinoidal limestone in Clitheroe it is very scarce. Despite their popular name of 'sea lilies', crinoids are animals related to sea urchins. Colour doesn't immediately come to mind when you look at fossil crinoids, but modern crinoids are very colourful and some even walk. Crinoids feed by catching small organisms as they float past their arms on the current.

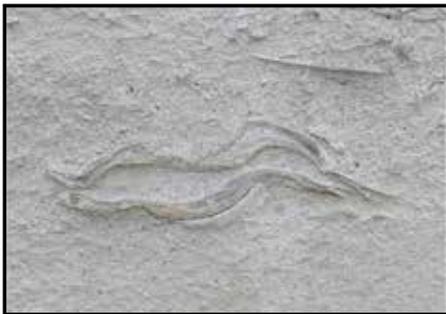
Portland Stone on the walls of Manchester
Central Library, St Peter's Square

The 145 million year old Jurassic limestone from Portland Bill was also deposited in an environment similar to that of Florida. It weathers almost white. Portland Stone has been used throughout the country in a huge number of high status monuments and buildings. The cenotaphs in London and Manchester are made from it. The Central Library (St Peter's Square, shown here), Ship Canal House (98 King Street) and several other central Manchester buildings are either built or faced with it. Most Portland Stone is oolitic and like Ketton freestone is readily carved. In Portland stone fossils also tend to weather out, so what starts as rather a dull texture becomes more attractive with age. The fossil illustrated is a bivalve. In Portland stone you can usually see individual ooids. You can certainly see them at the Library, but you have to look closely.

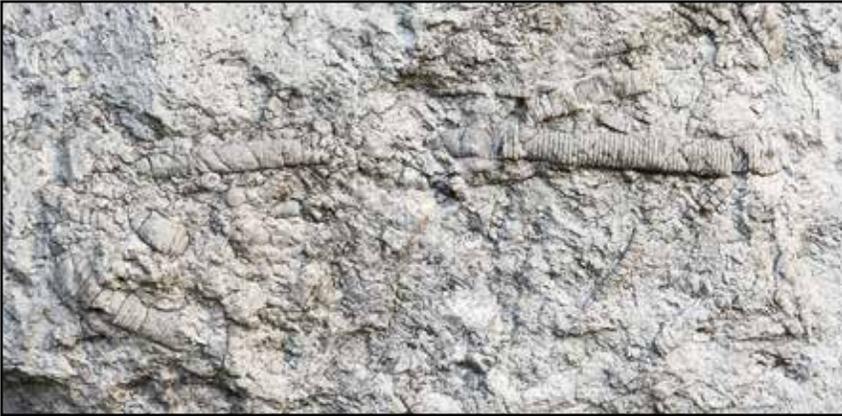
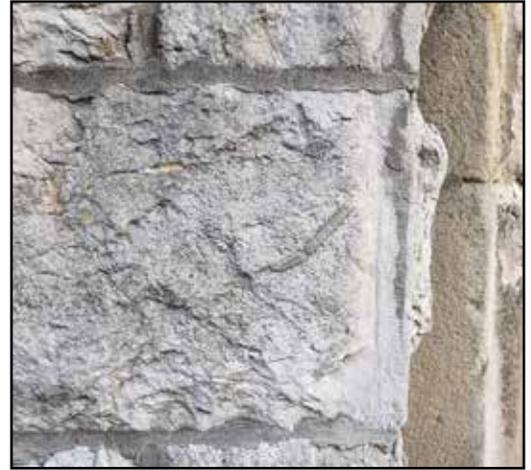
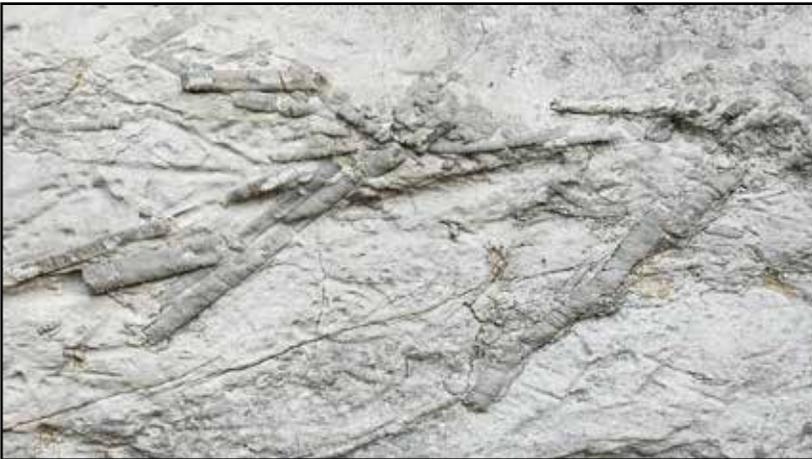
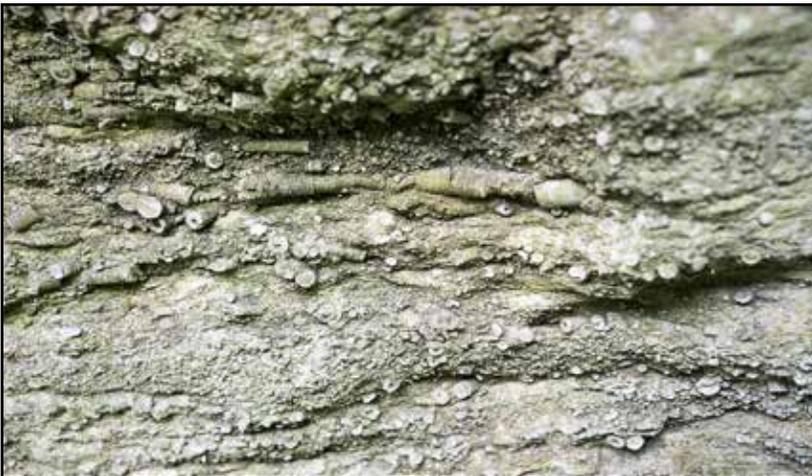
Top and left:
Crinoids and other fossils in the wall of the United Reformed Church, Moor Lane, Clitheroe.

Left:
Crinoidal limestone in Salthill Quarry, Clitheroe.

Right:
Non-crinoidal limestone in Salthill Quarry, Clitheroe.

Limestone found at Salthill is of two principal types, one coloured a uniform grey and devoid of fossils large enough to see without a microscope and the other replete with fossil crinoids.

The strong grey uniform rock type could be carved with difficulty but the crinoidal variety could not because crinoids fracture along cleavage planes and therefore unevenly. The crinoidal limestone is attractive when used in blocks because the crinoids stand proud on a weathered surface. The calcite in crinoids has a well-ordered molecular structure, making it

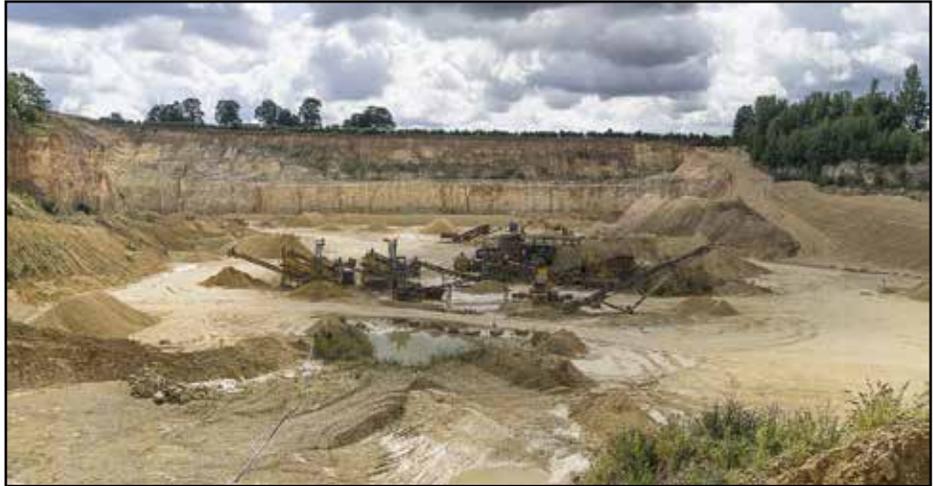
Jackdaw Quarry, Tadcaster

Clipsham and this was the stone which was referred to in the tender documentation. However, in an article in the *Natural Stone Specialist* by Dr David Jefferson, Jefferson Consulting, it was indicated that there could be a detrimental effect if Clipsham stone was laid adjacent to the Anston Magnesian limestone. This persuaded the project team and their professional advisors that the better stone to use would be Magnesian Limestone sourced from the Jackdaw Crag Quarry near Tadcaster in North Yorkshire.

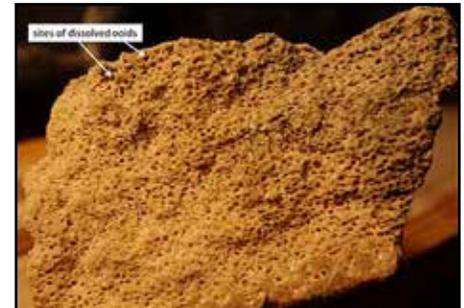
Example of magnesian limestone from Sunderland showing voids

This piece is 50mm wide

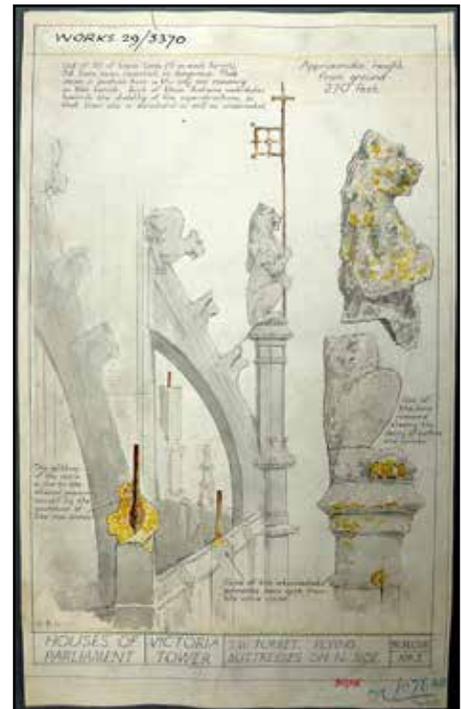
A watercoloured drawing used to illustrate the damage in the 1920s.

In the 1920s it was evident that some pinnacles were in such a poor state of repair that they would need to be replaced. In 1928 the Department of Scientific and Industrial Research produced a comprehensive report, marked 'Strictly Confidential'.
